Manhole Inspection Summary

Manhole # S35A__004MH

Insp Date: **11/14/08 11:03 AM**

Location Address: **618 st paul st**

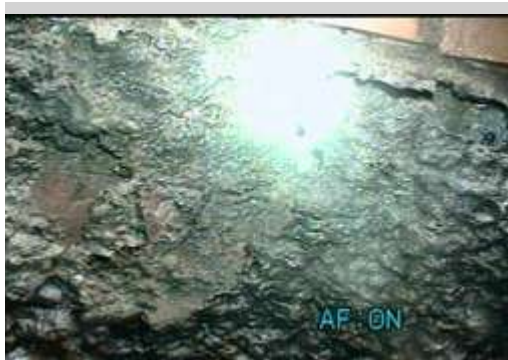
Defect 3

Condition: ☐ Sound ☐ Cracked ☐ Root Intrusion ☐ Loose Brick ☒ **Deteriorated**

corbel deteriorated

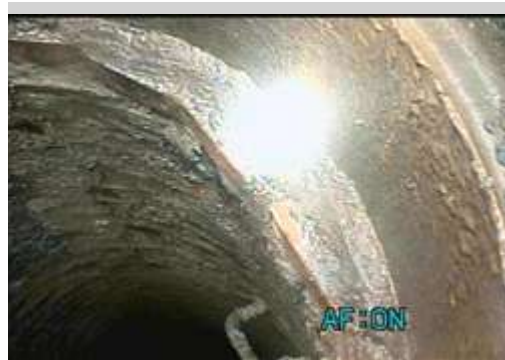
Defect 2

Frame Offset: **2** (in.) Condition: ☒ Sound ☐ Cracked ☐ Leaks

frame offset 2 inches

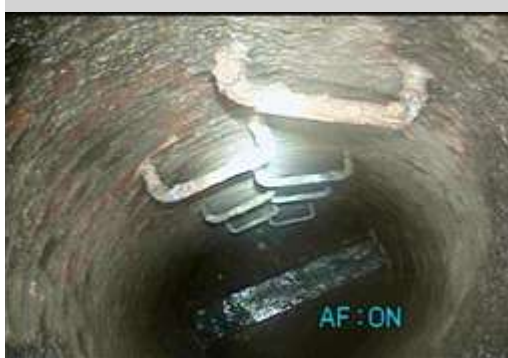
Defect 1

Steps Count: **7** Missing: **0** ☒ **Corroded**

steps corroded

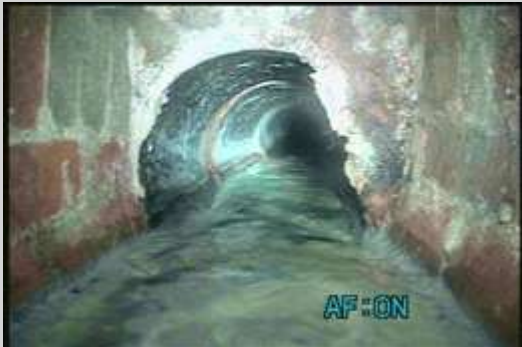
12 O'Clock Outflow

10 in. Circular Gravity Sewer
Pipe Out @ 12 O'Clock

Pipe Material: **Clay** ☐ Pipe Lined

Invert Depth: **12.25** (ft.) Flow Characteristics: **Fast**

Infiltration: **None** Pipe Seal Cond: **Unknown**

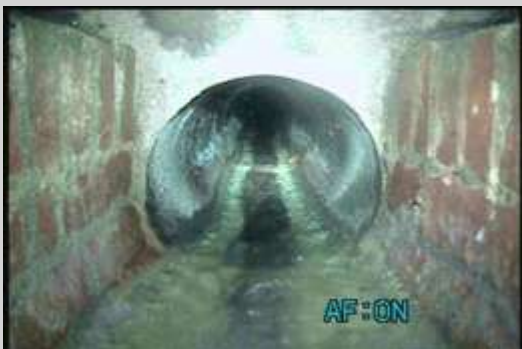
6 O'Clock Inflow

10 in. Circular Gravity Sewer
Pipe In @ 6 O'Clock

Pipe Material: **Clay** ☐ Pipe Lined

Invert Depth: **12.20** (ft.) Flow Characteristics: **Fast**

Infiltration: **None** Pipe Seal Cond: **Unknown**
